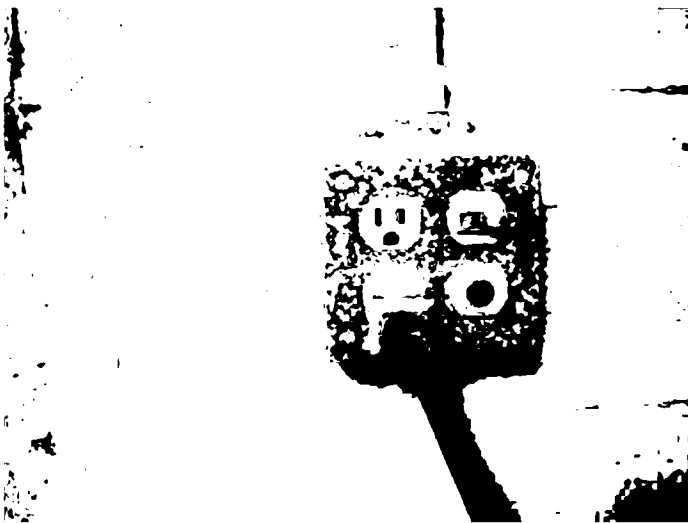
Pool Chemical Room - Surface-mounted outlet with heavy corrosion.

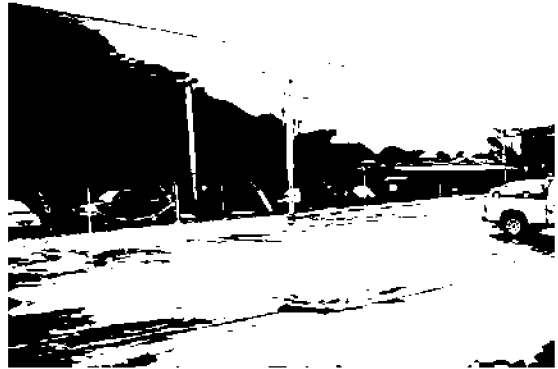
Comment:
Heat loss through second door
