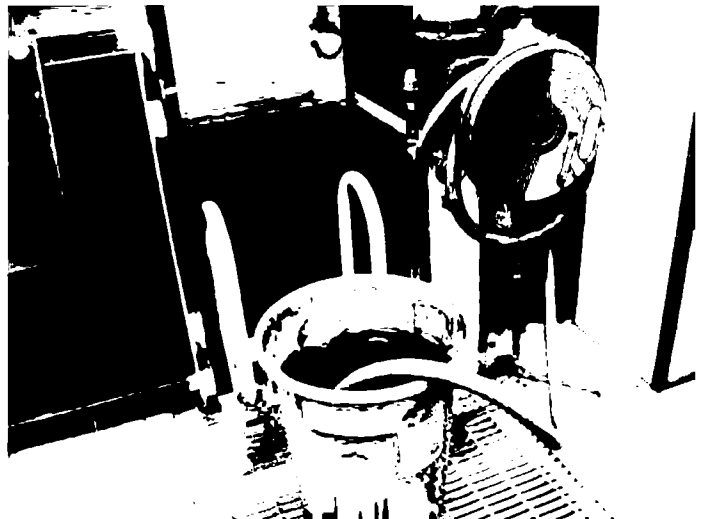
Pool Pump Room - Access to perlite filtration tank.

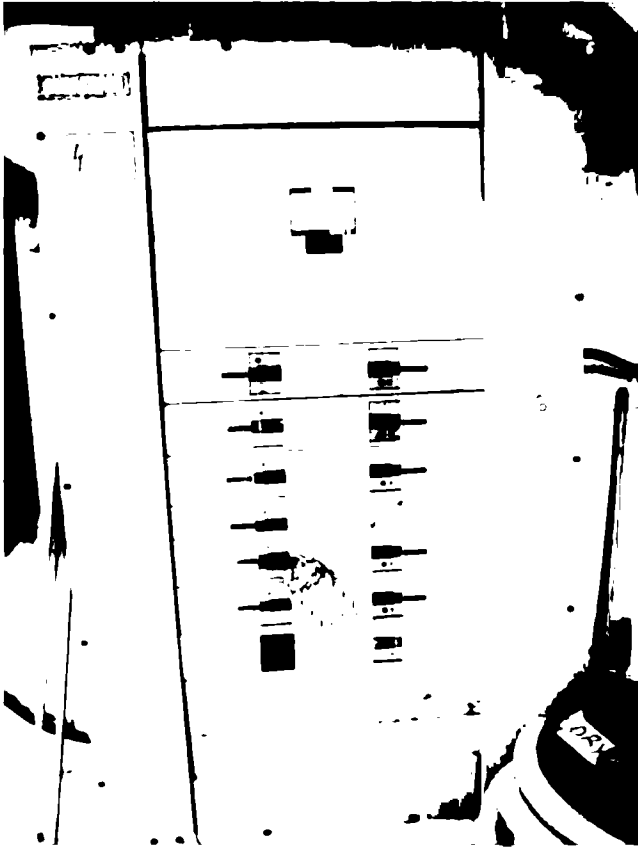
Pool Pump Room - Distribution panel for pool heaters, pumps and controllers.

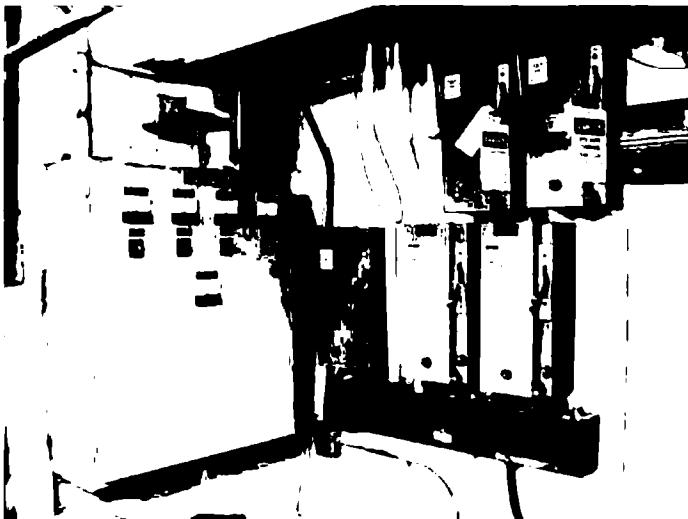
Pool Pump Room - Abandoned South Wall Equipment

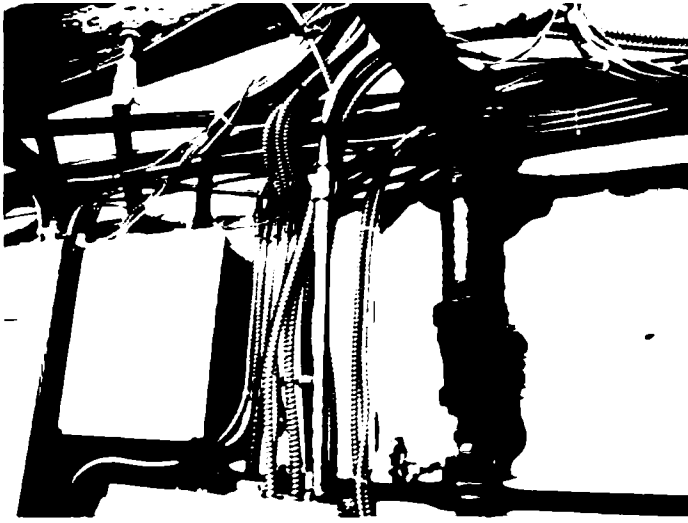
Work Shed Access Hallway - Typical services congestion.

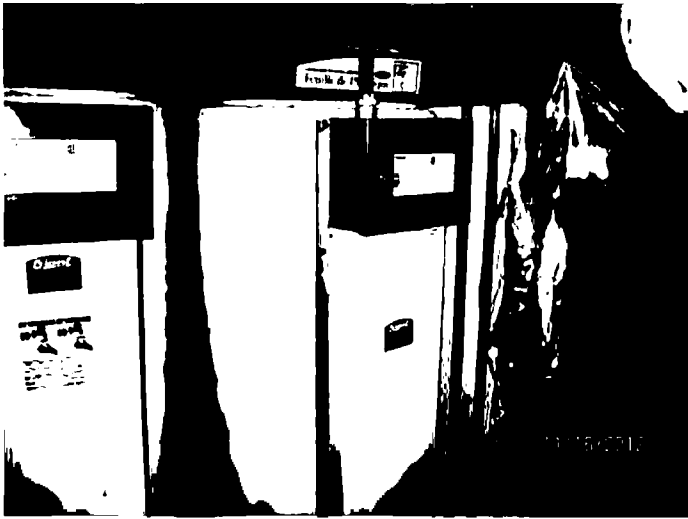
Boiler Room - Domestic Hot Water Heaters.

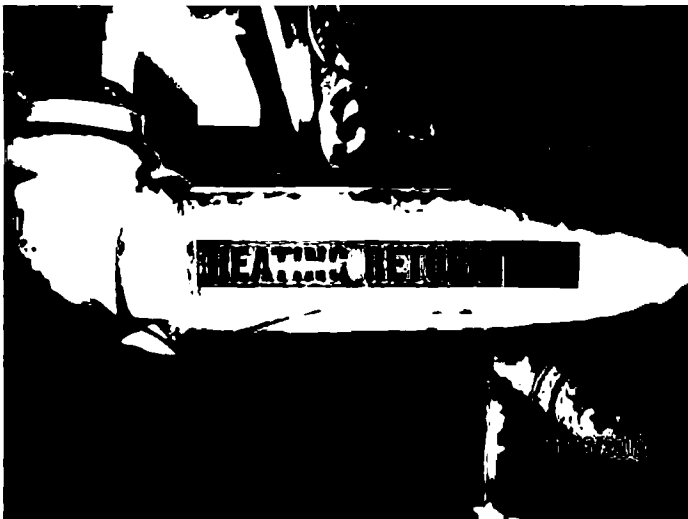
Boiler Room - Typical heating water return piping.

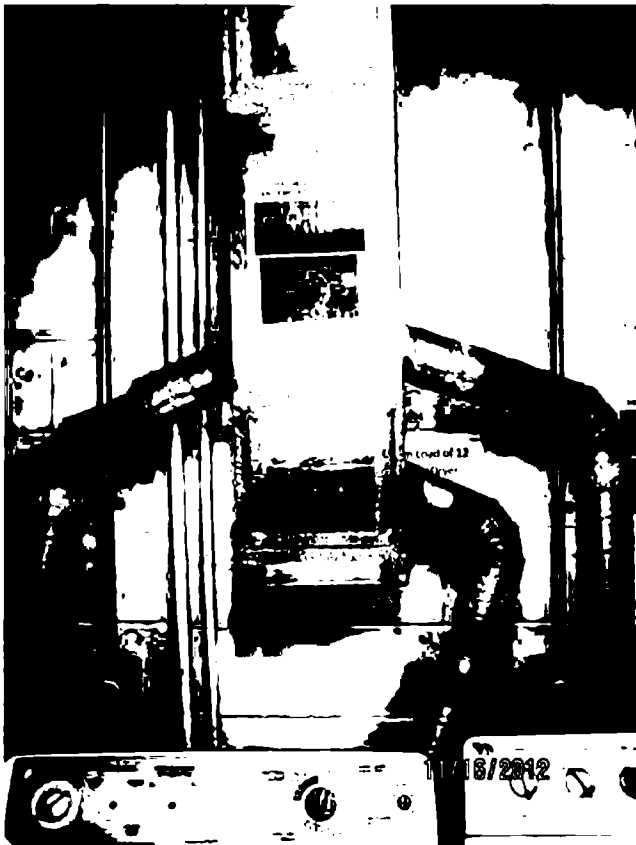
Laundry Room - Drier exhaust system with clean-out hatch taped shut.

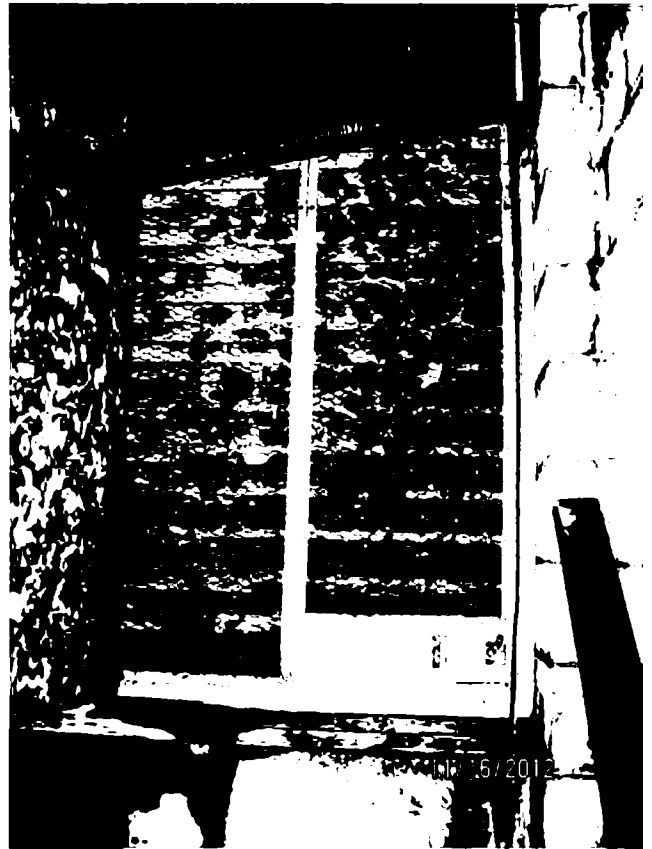
Air Handler Room - Outside air Louver.
