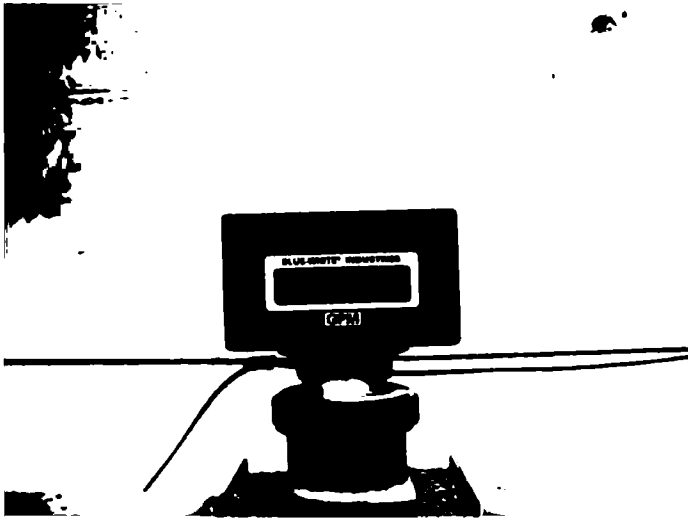
Pool Pump Room - Pool filtration system flow meter.

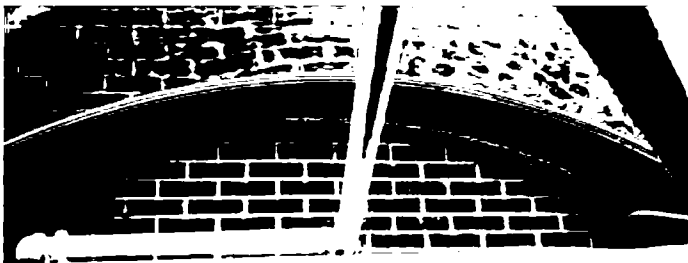
Pedway - Possible location for transfer terminal from Heating Water Pump Room.

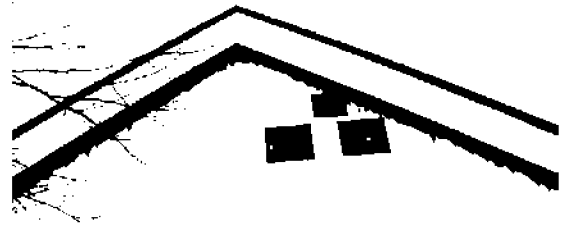
Date	12/4/2012	Location:	
Image Time	8:32:31 PM	Other remarks:	
Filename	IR_0031.jpg		
Emissivity	0.95		
Object Distance	15.0 m		
Reflected Apparent Temperature	6.0 °C		
Atmospheric Temperature	6.0 °C		
Relative Humidity	85.0 %		
Sp1 Temperature	5.5 °C

Comment:
Close-up of upper south wall
